NL INDUSTRIES/TARACORP SUPERFUND SITE GROUP
Leed Environmental, Inc.
Van Reed Office Plaza
2209 Quarry Drive, Suite C-35
Reading, PA 19609
Telephone: (610) 670-7310
Facsimile: (610) 670-7311

Re: NL Industries/Taracorp Superfund Site; Granite City, Illinois
First 2020 Semi-Annual Operation and Maintenance Inspection (June 2020)

**NL Industries/Taracorp Superfund Site
Inspection Log - Operation and Maintenance**

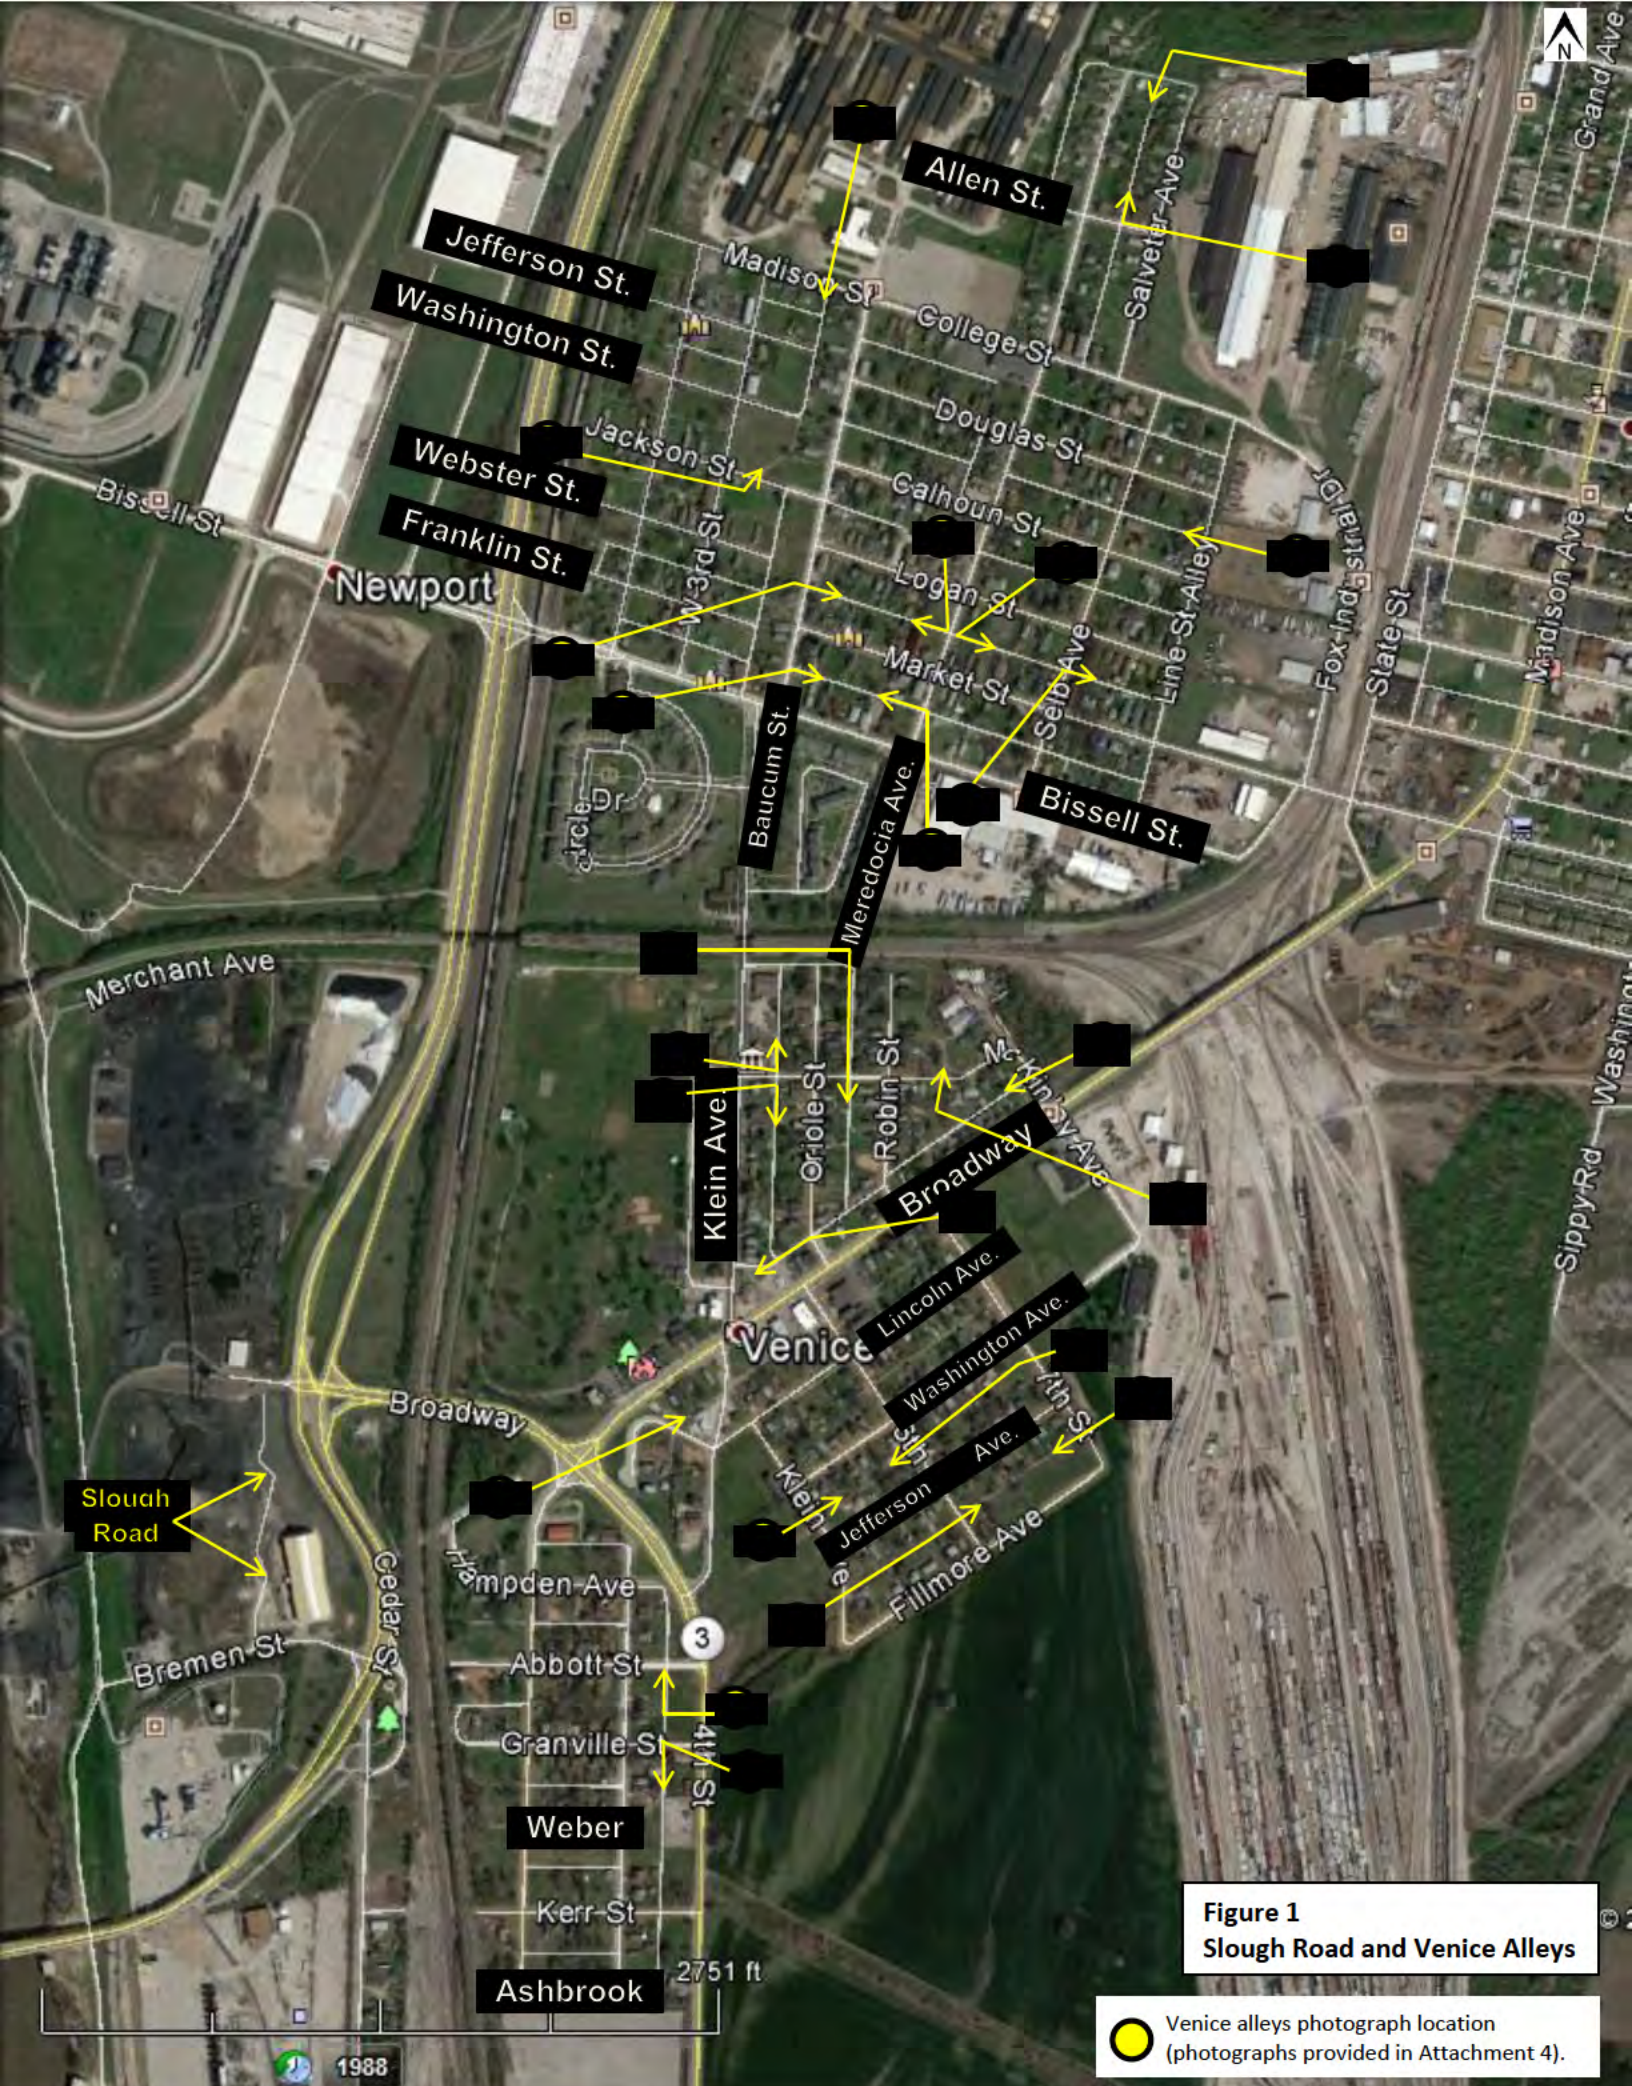
Figure 1
Slough Road and Venice Alleys

- At Slough Road (shown on Figure 1 and the photographs in Attachment 1), no disturbance of the gravel cover to the previously paved area was observed. Also, I met with Mr. Earl Boyd, Terminal Manager for Beelman River Terminals, Inc. (Beelman), who confirmed that there has been no disturbance to the paved surface of Slough Road (which is no longer visible) since the time the paved roadway was covered with soil/gravel fill as part of the expansion of Beelman's operations. Mr. Boyd also indicated that Ameren has placed stakes into the ground to mark the location of its new electrical transmission tower; this area was not observed, but the area is located outside (to the west/southwest) of the former Slough Road area. Some scattered battery case chips were observed on the concrete foundation of the former Robin's Nest lounge.

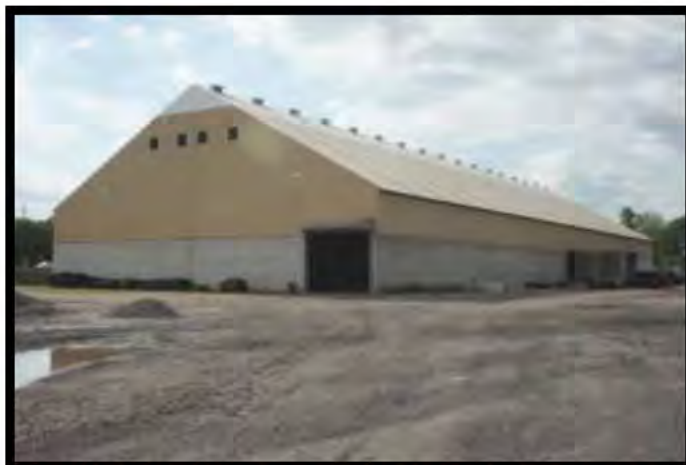
Photograph 1: Beelman storage area/warehouse.

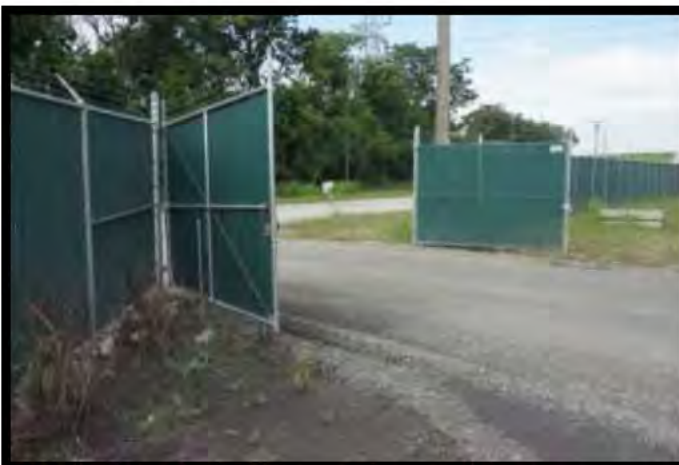
Photograph 2: Fence/gate (view from inside Beelman property).

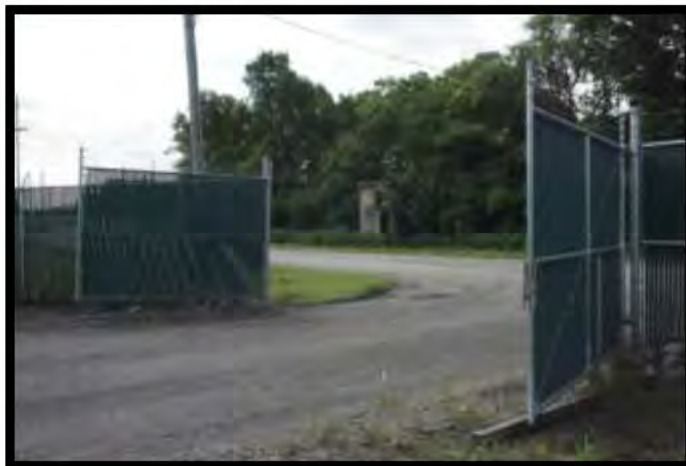
Photograph 3: Fence/gate (view from inside Beelman property).

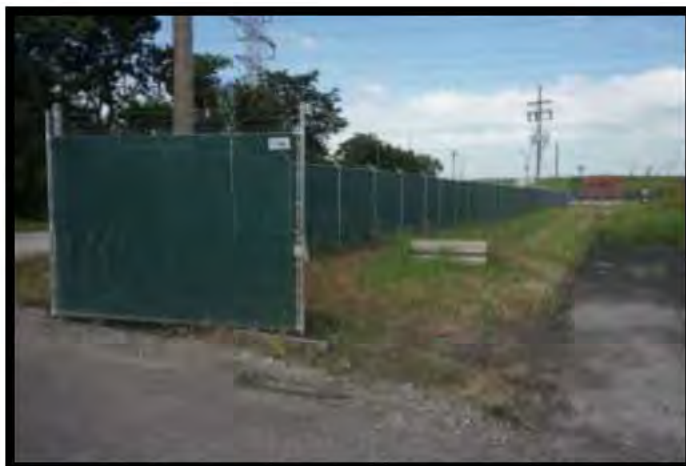
Photograph 5: Fence along Bremen Street.

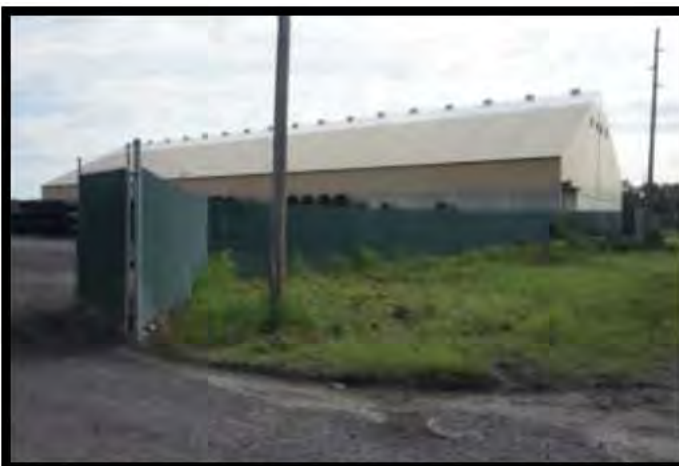
Photograph 6: Fence along Bremen Street (view from Bremen Street).

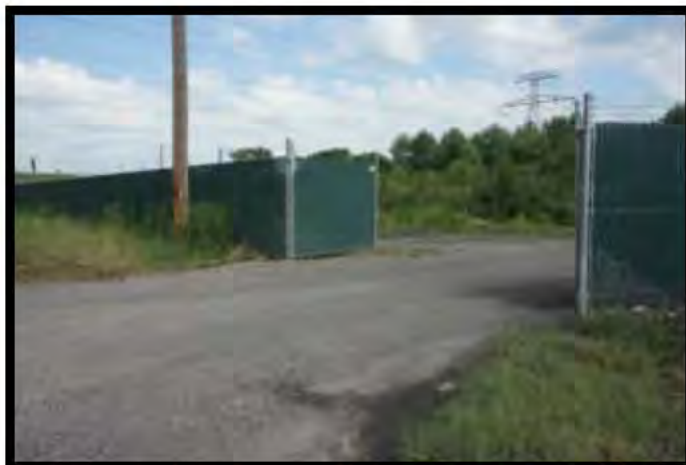
Photograph 7: Fence along Bremen Street (view from Bremen Street).

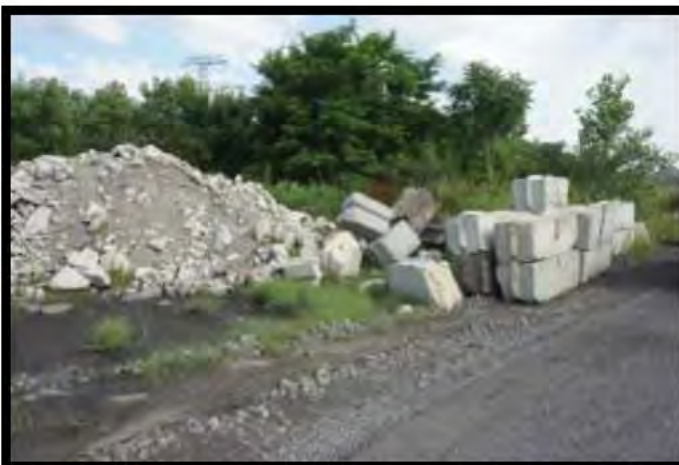
Photograph 8: Slough Road, concrete debris.

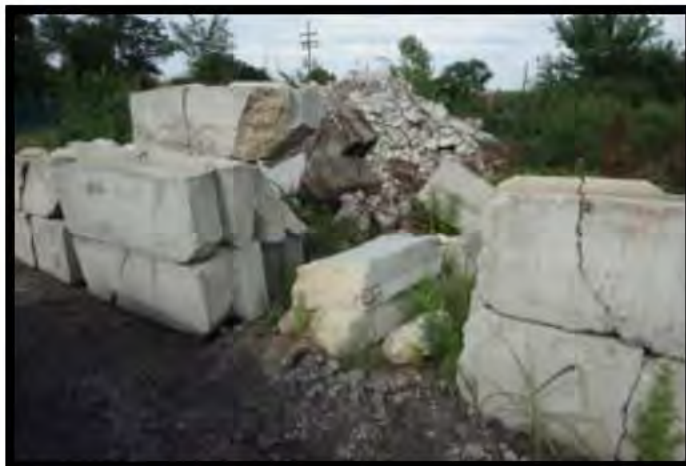
Photograph 9: Slough Road, concrete debris.

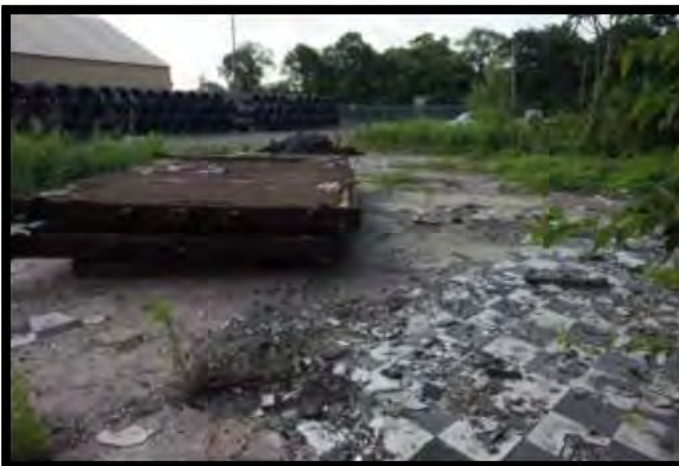
Photograph 10: Slough Road, concrete foundation of former Robin's Nest lounge.

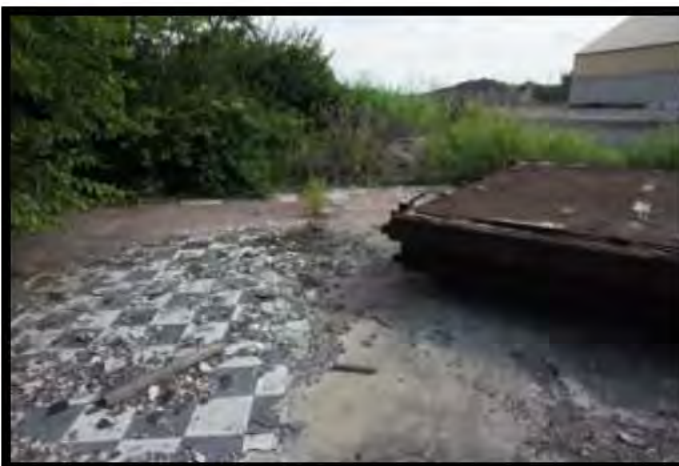
Photograph 12: Slough Road, concrete foundation of former Robin's Nest Lounge.

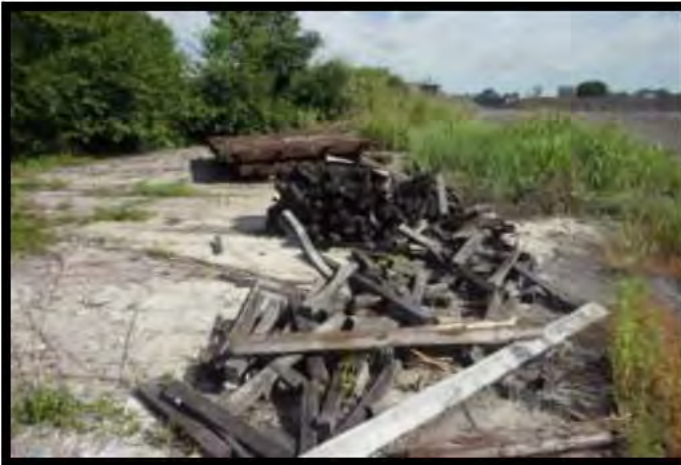
Photograph 13: Slough Road, wood debris piles on concrete foundation of former Robin's Nest lounge.

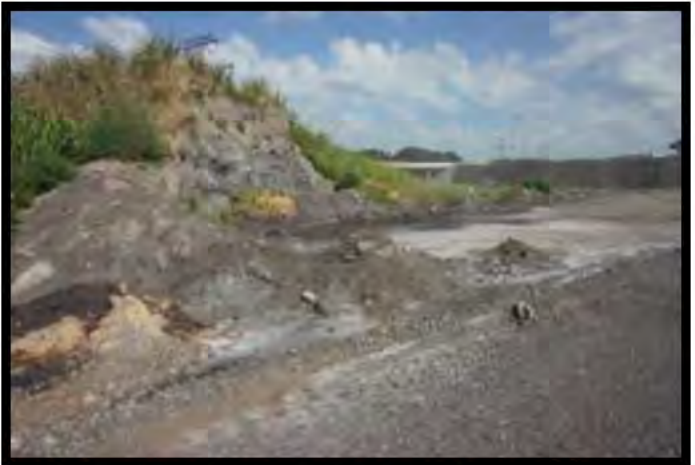
Photograph 14: Slough road, soil pile.

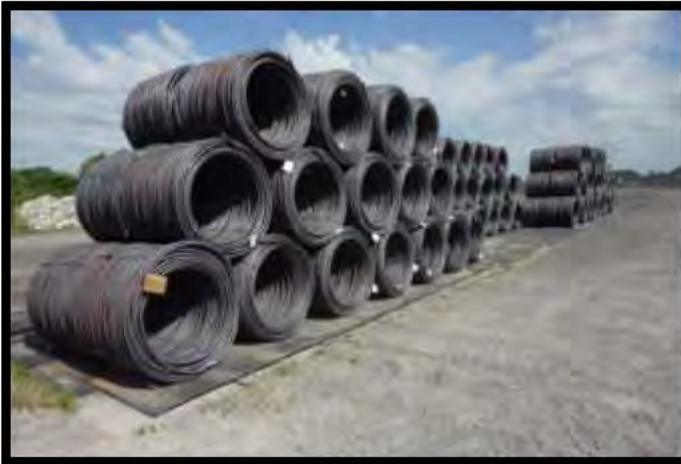
Photograph 15: Storage of Beelman equipment.

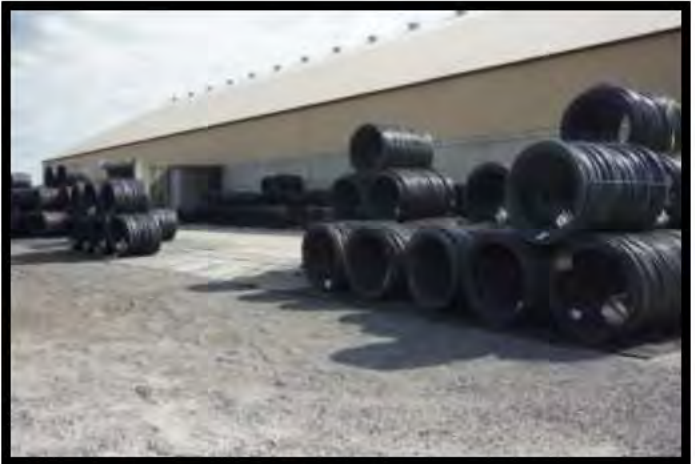
Photograph 16: Storage of Beelman equipment.

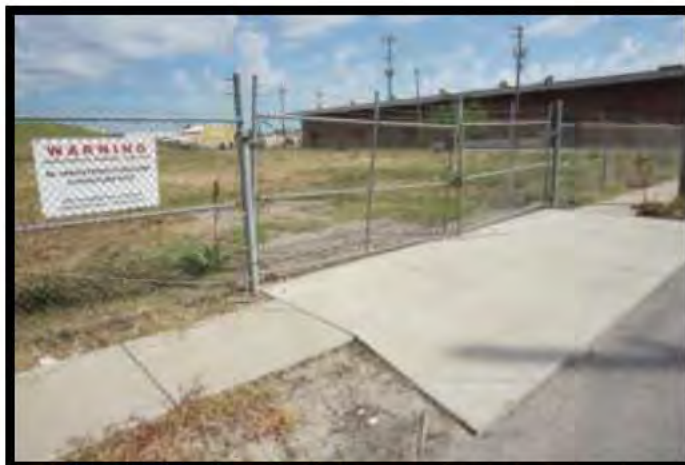
Photograph 1: Entrance to 1555 State Street property along State Street.

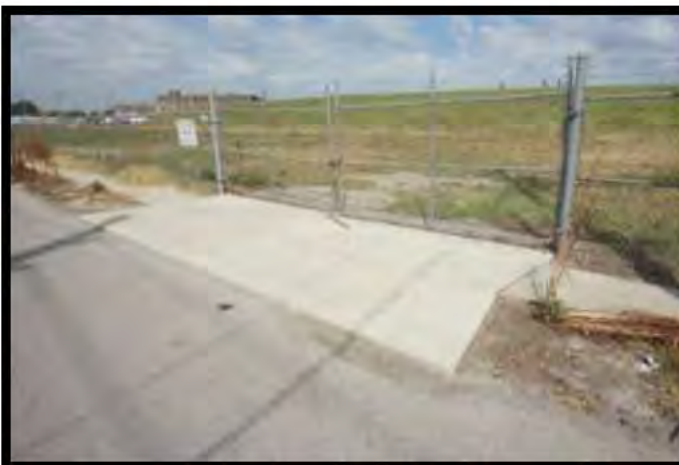
Photograph 2: Entrance to 1555 State Street property along State Street.

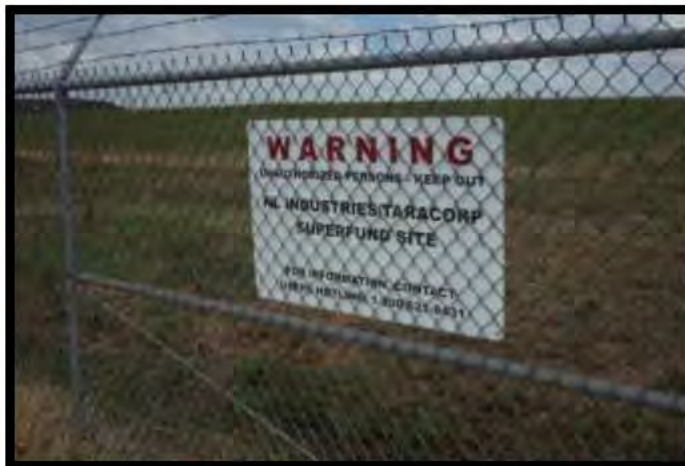
Photograph 3: Warning sign at front gate along State Street.

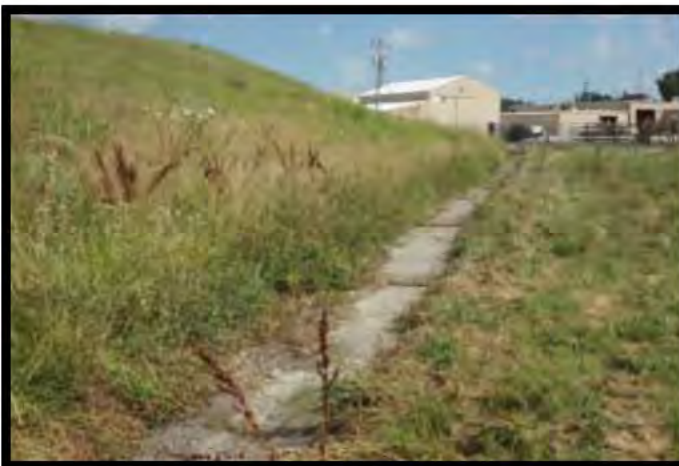
Photograph 4: Concrete drainage swale, east side of Taracorp pile (view north).

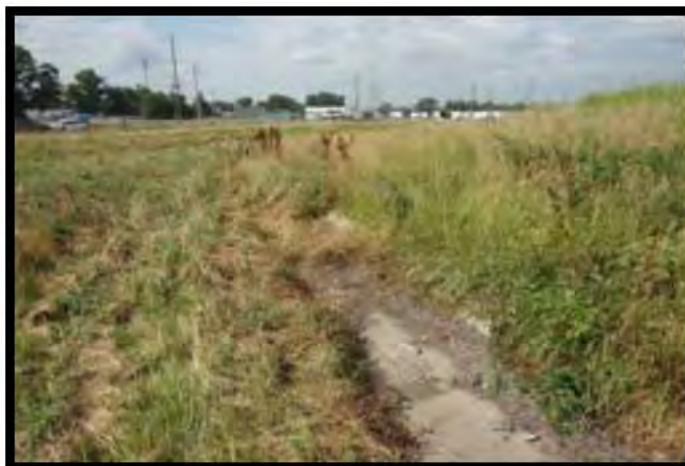
Photograph 5: End of concrete drainage of swale, east side of Taracorp pile.

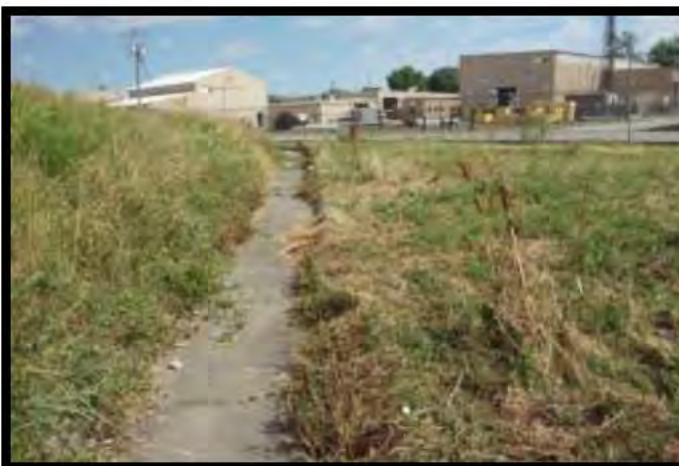
Photograph 6: Concrete drainage swale, east side of Taracorp pile (view north).

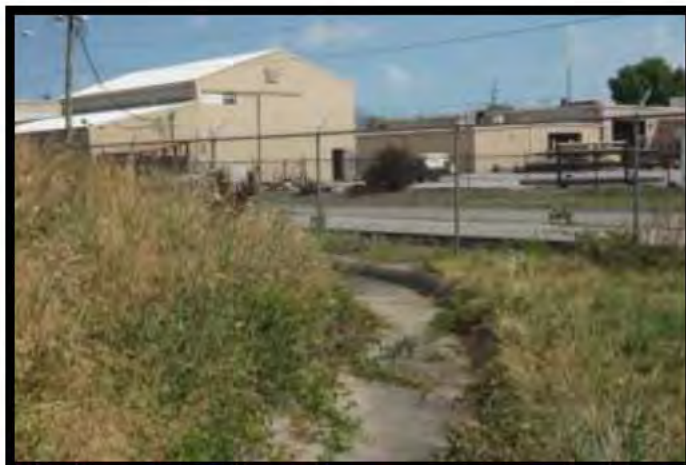
Photograph 7: Concrete drainage swale, east side of Taracorp pile (view north).

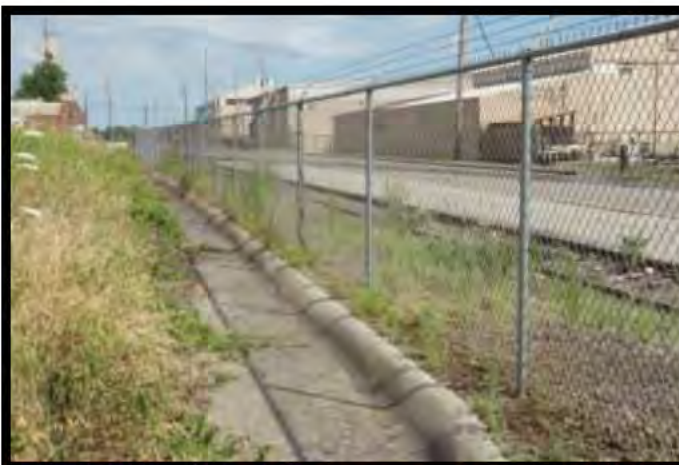
Photograph 8: Concrete drainage swale, east side of Taracorp pile (view north).

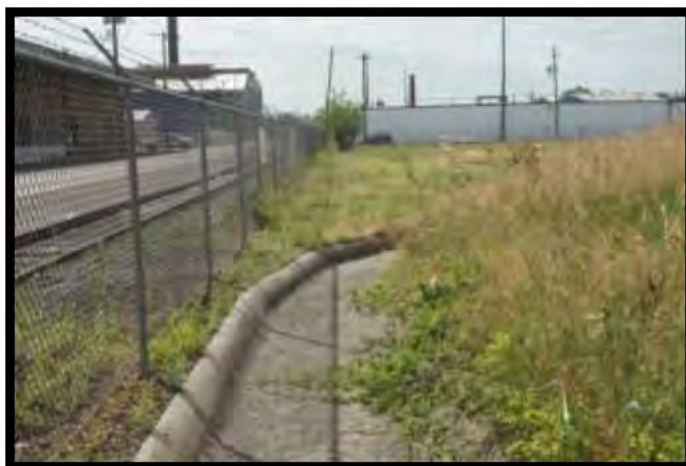
Photograph 9: Concrete drainage swale, north side of Taracorp pile (view southeast).

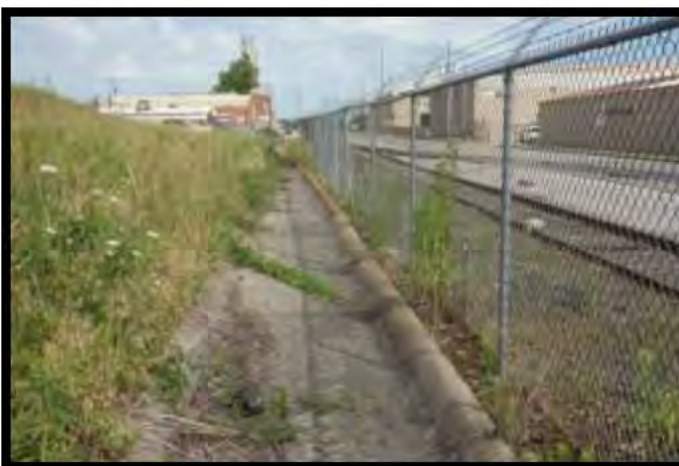
Photograph 10: Concrete drainage swale, fence, and vegetation; north side of Taracorp pile along 16th Street (view northwest).

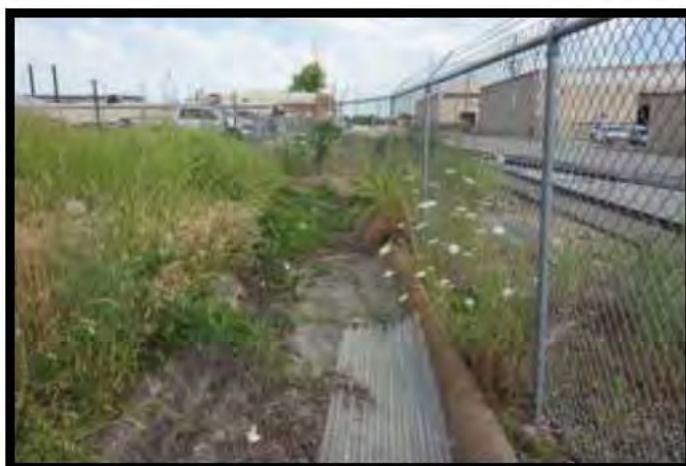
Photograph 11: Concrete drainage swale, fence, and vegetation; north side of Taracorp pile along 16th Street (view northwest).

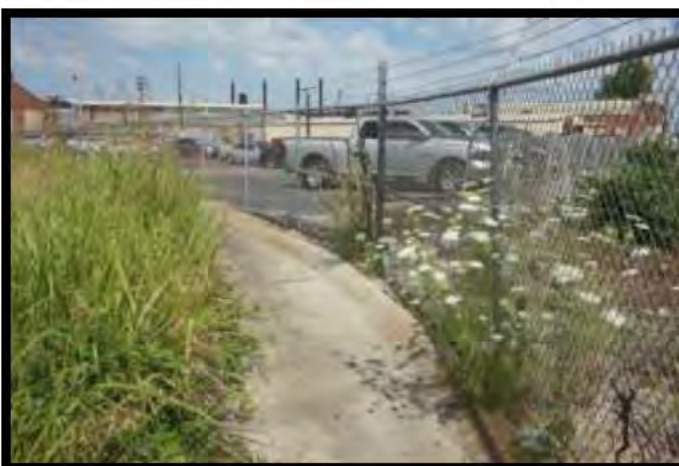
Photograph 12: Concrete drainage swale, fence, and vegetation; north side of Taracorp pile along 16th Street (view northwest).

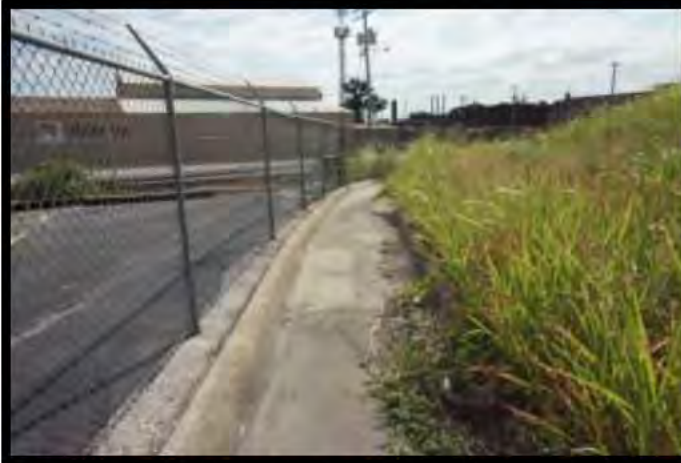
Photograph 13: Concrete drainage swale and vegetation; northwestern side of Taracorp pile (view northeast).

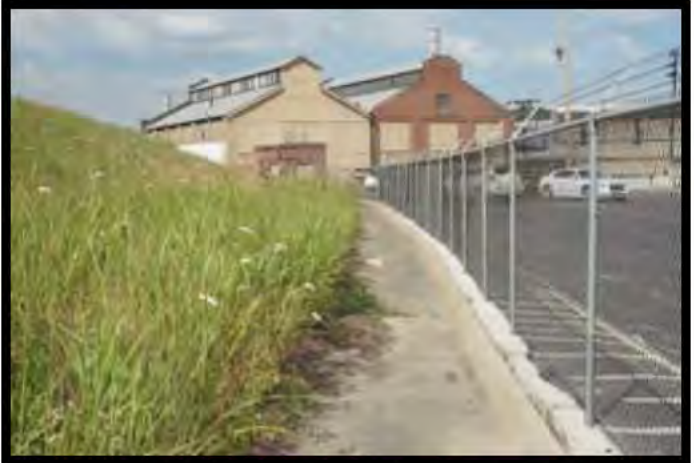
Photograph 14: Vegetation, northwestern side of Taracorp pile cap (view southwest).

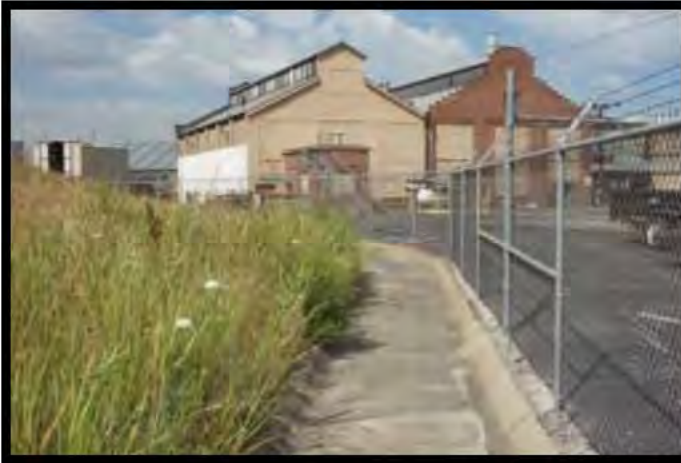
Photograph 15: Concrete drainage swale, fence, and vegetation along northwestern side of Taracorp pile (view southwest).

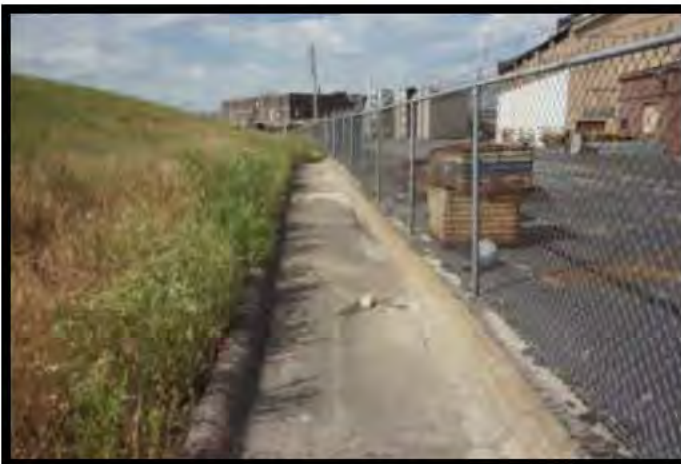
Photograph 17: Concrete drainage swale, fence, and vegetation along northwestern side of Taracorp pile (view southwest).

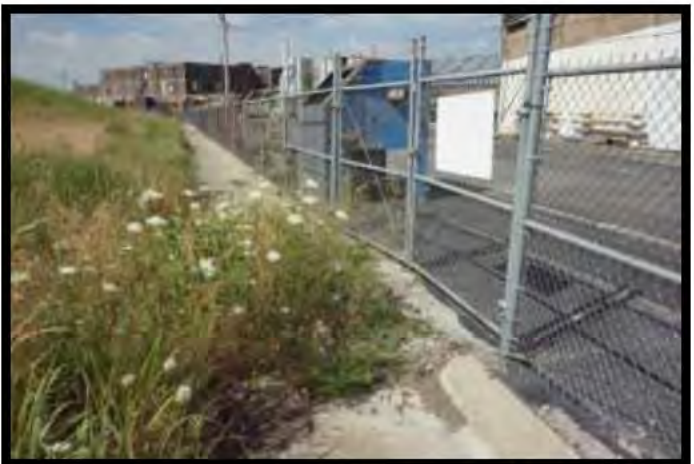
Photograph 18: Concrete drainage swale, fence, and vegetation along northwestern side of Taracorp pile (view southwest).

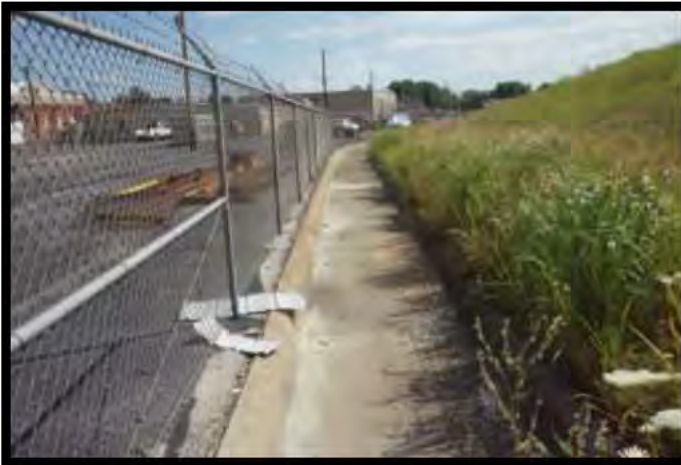
Photograph 19: Concrete drainage swale, vegetation along northwestern side of Taracorp pile (view north/northeast).

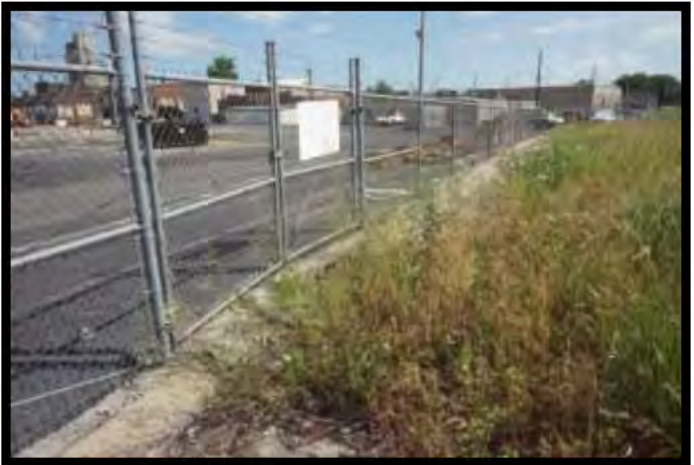
Photograph 20: Fence, warning sign, western side of Taracorp pile.

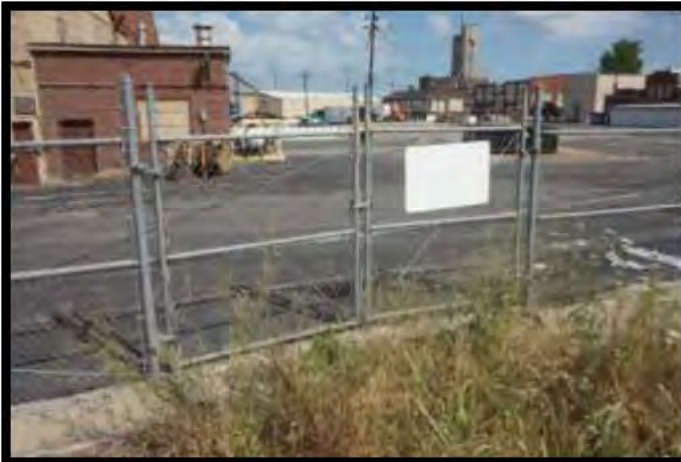
Photograph 21: Fence, warning sign, western side of Taracorp pile.

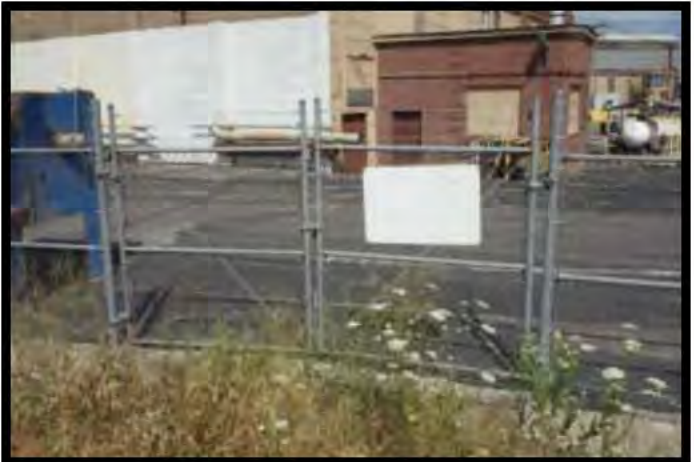
Photograph 22: Fence, warning sign, western side of Taracorp pile.

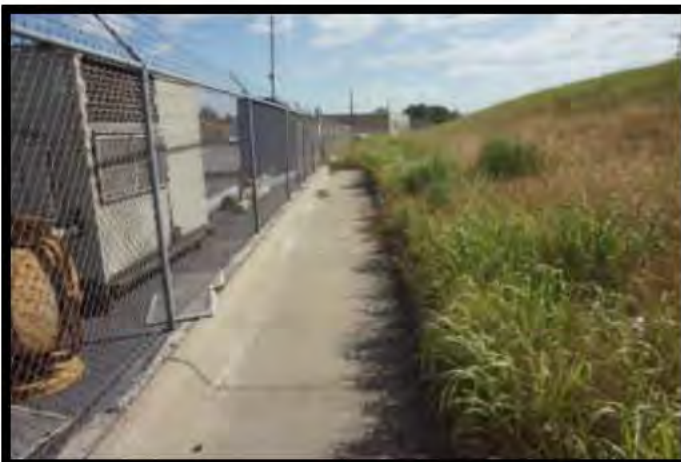
Photograph 23: Vegetation near base of western side of Taracorp pile (view north).

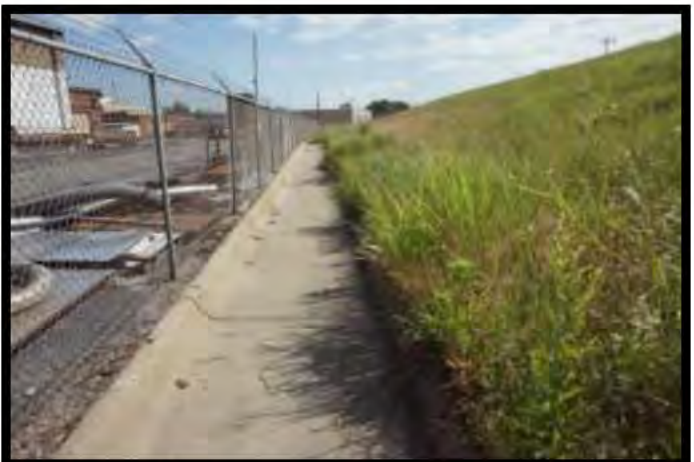
Photograph 24: Concrete drainage swale and vegetation near base of western side of Taracorp pile (view north).

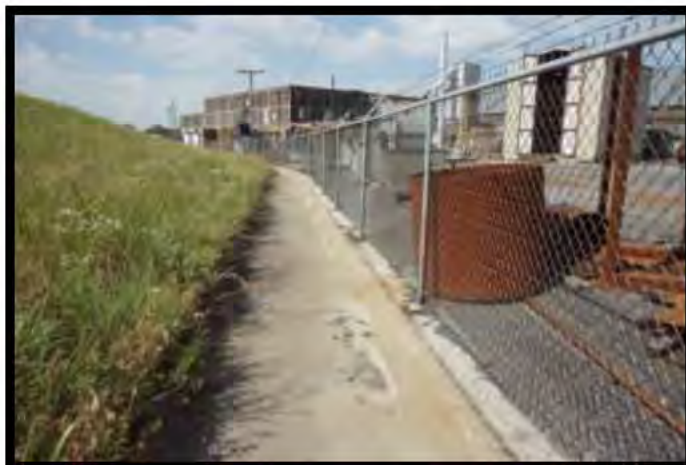
Photograph 25: Concrete drainage swale and vegetation near base of western side of Taracorp pile (view south).

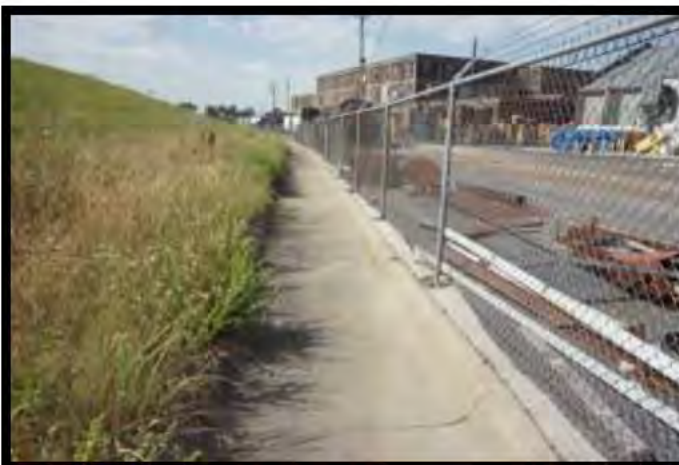
Photograph 26: Concrete drainage swale and vegetation near base of western side of Taracorp pile (view south).

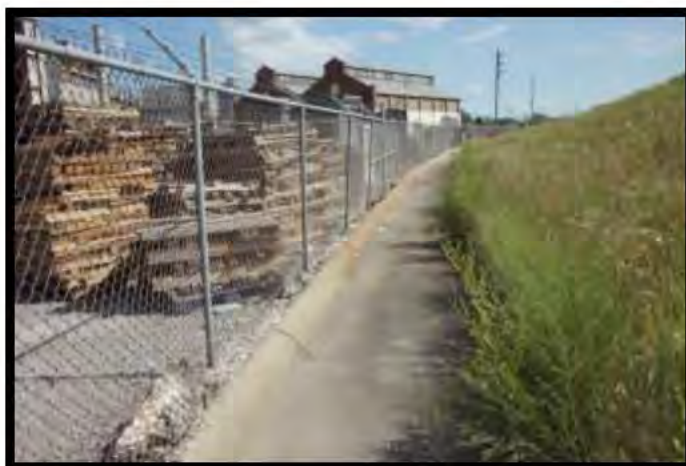
Photograph 27: Concrete drainage swale and vegetation near base of western side of Taracorp pile (view north).

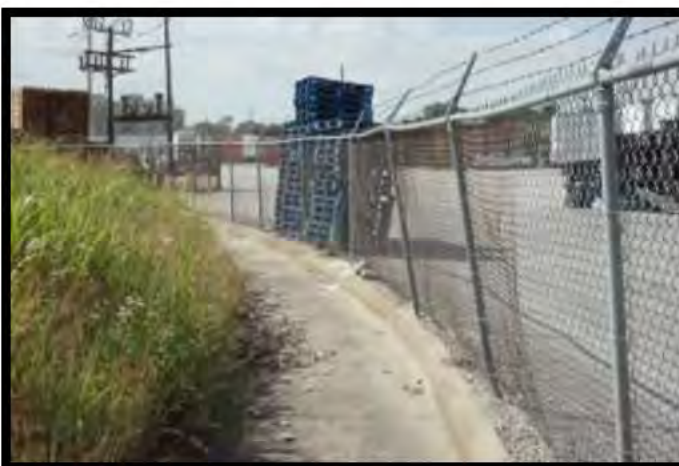
Photograph 28: Concrete drainage swale and vegetation near base of western side of Taracorp pile (view south).

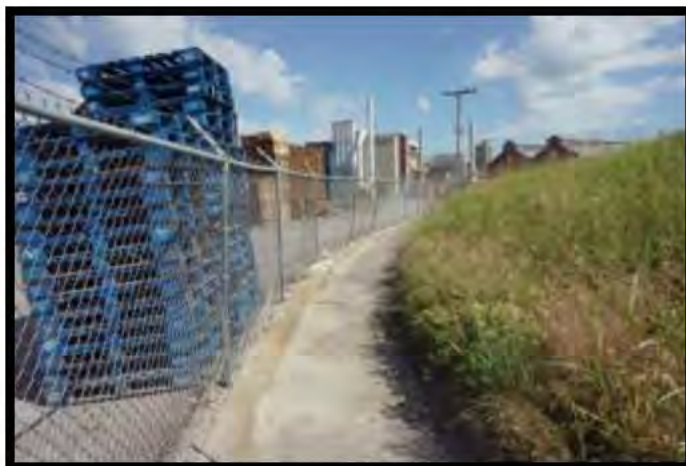
Photograph 29: Concrete drainage swale, western side of Taracorp pile (view north).

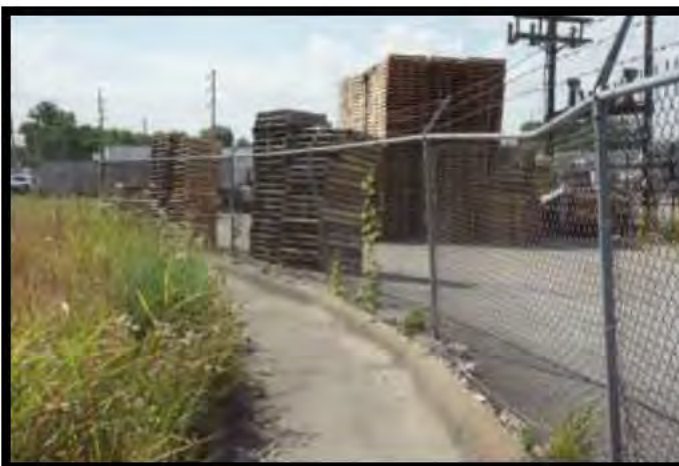
Photograph 30: Concrete drainage swale and vegetation near base of western side of Taracorp pile (view south).

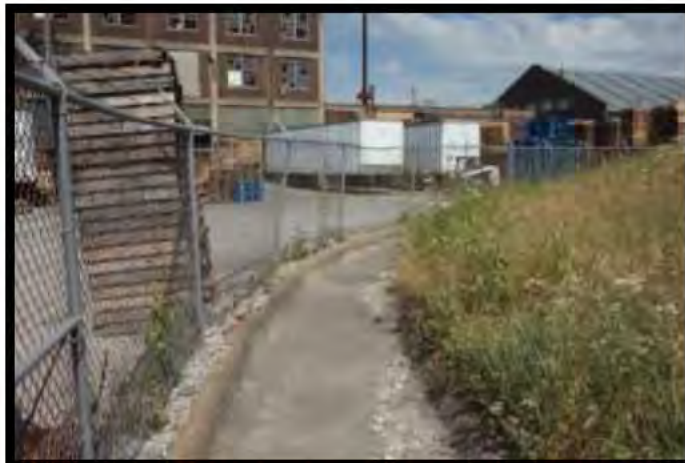
Photograph 31: Fence and concrete drainage swale, southwestern side of Taracorp pile cap (view north).

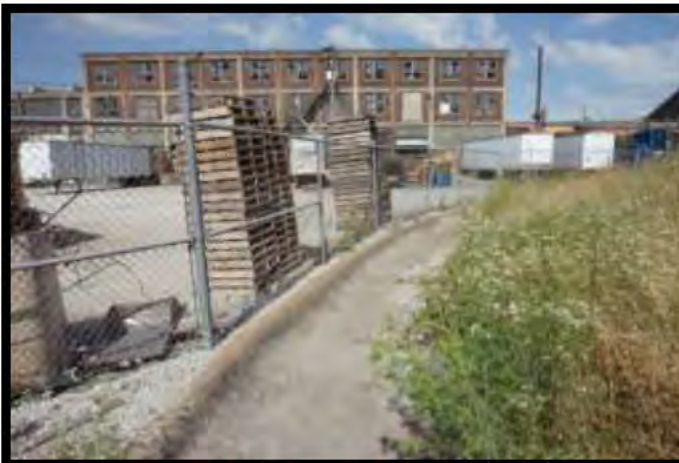
Photograph 32: Fence and concrete drainage swale, southwestern side of Taracorp pile cap (view west).

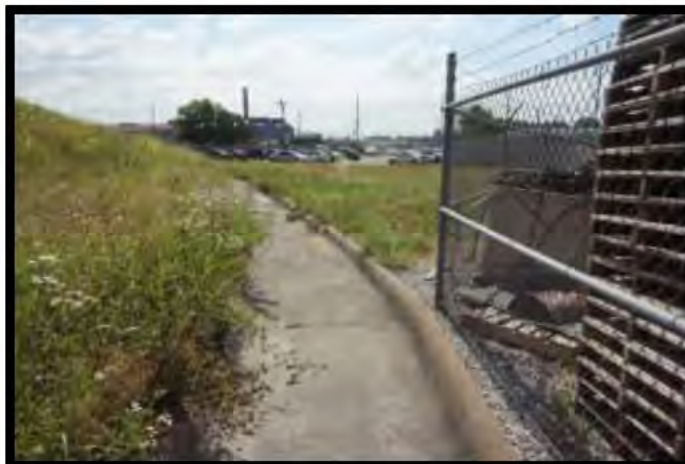
Photograph 33: Fence and concrete drainage swale, southwestern side of Taracorp pile cap (view south).

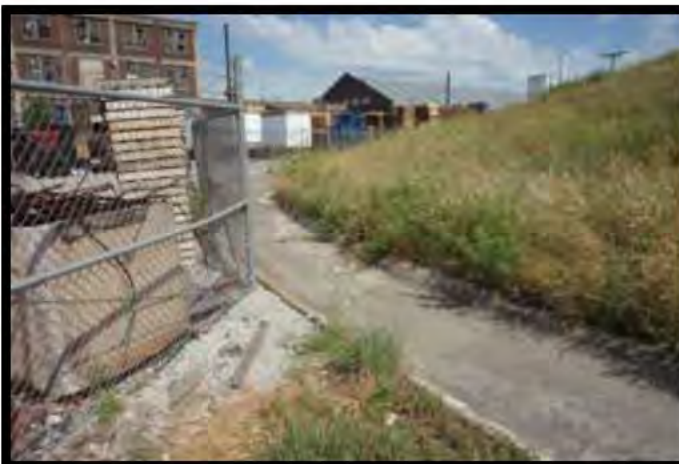
Photograph 34: Fence and concrete drainage swale, southwestern side of Taracorp pile cap (view north).

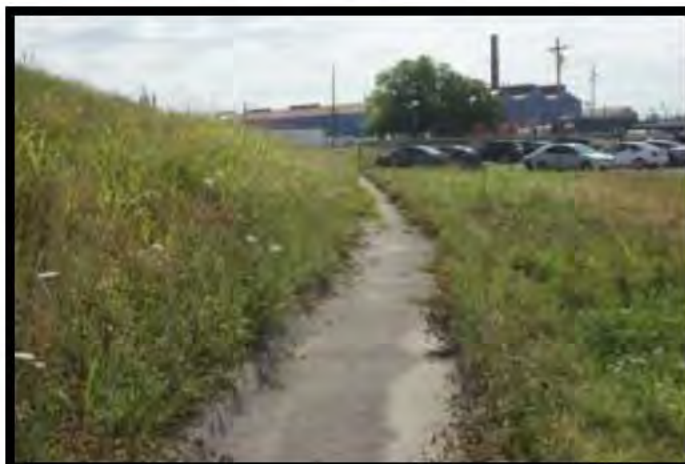
Photograph 35: Fence and concrete drainage swale, southwestern side of Taracorp pile cap (view east).

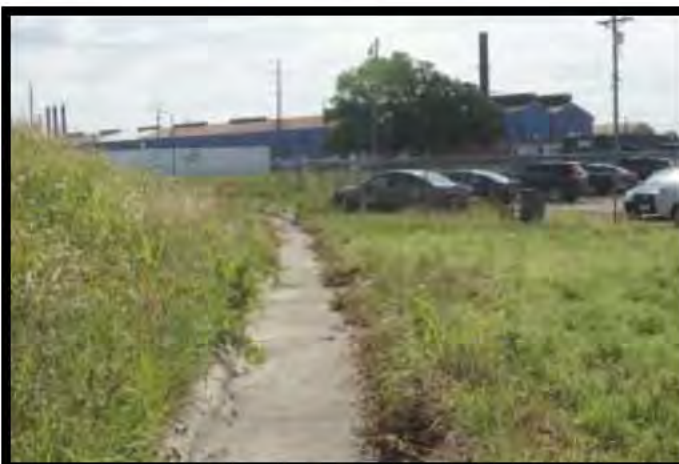
Photograph 36: Fence and concrete drainage swale, southwestern side of Taracorp pile cap (view east).

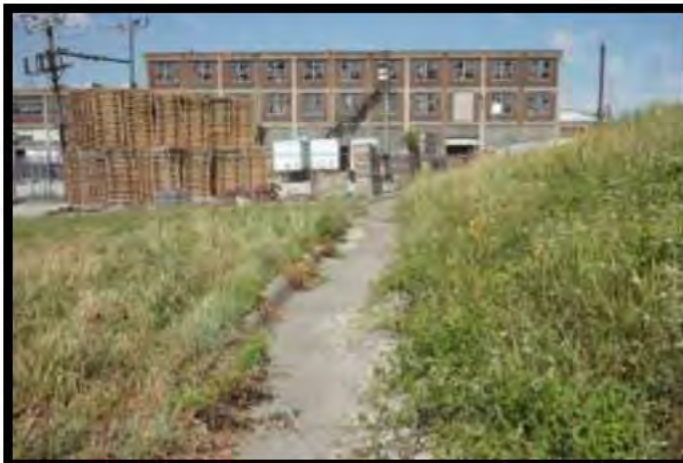
Photograph 37: Fence and concrete drainage swale, southwestern side of Taracorp pile cap (view east).

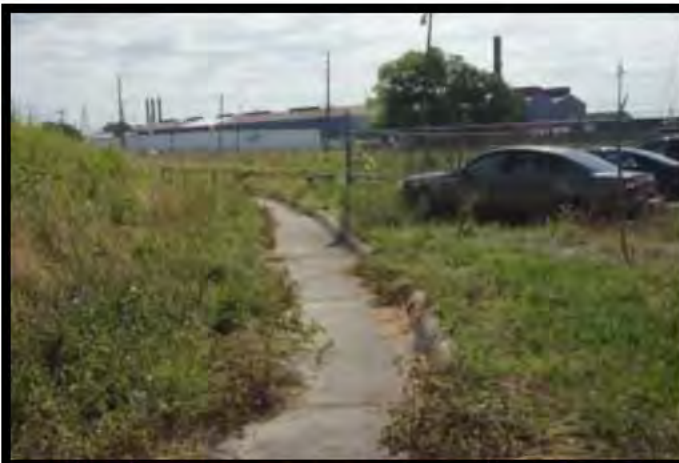
Photograph 38: Fence and concrete drainage swale, southwestern side of Taracorp pile cap (view east).

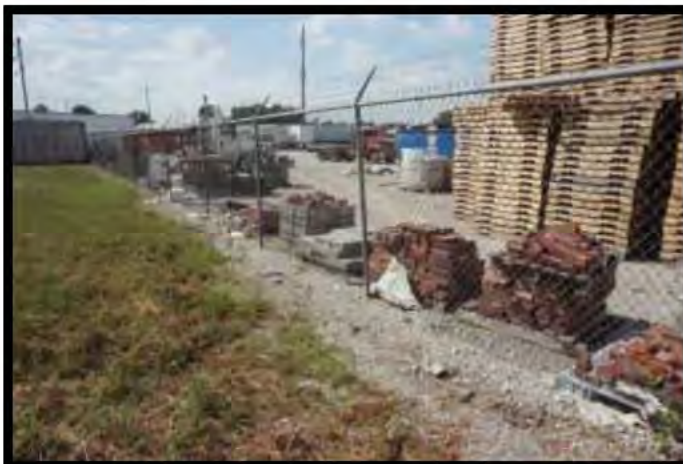
Photograph 39: Fence along State Street Warehouse storage area.

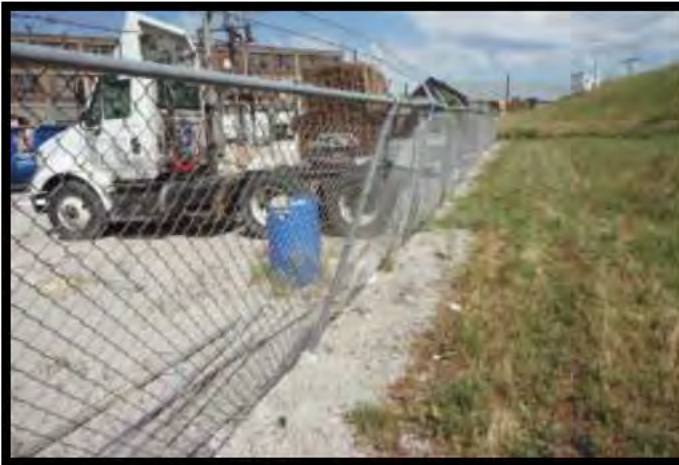
Photograph 43: Bent fence along State Street Warehouse property storage area.

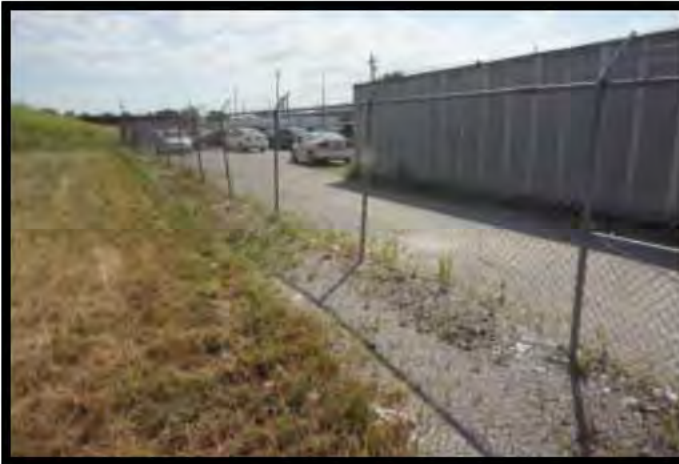
Photograph 45: Fence (parking area on State Street Warehouse property).

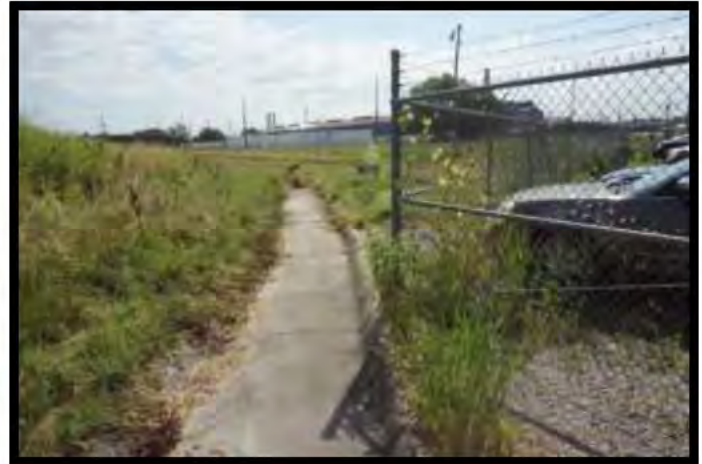
Photograph 46: Vegetation and concrete drainage swale along southern slope of Taracorp pile cap.

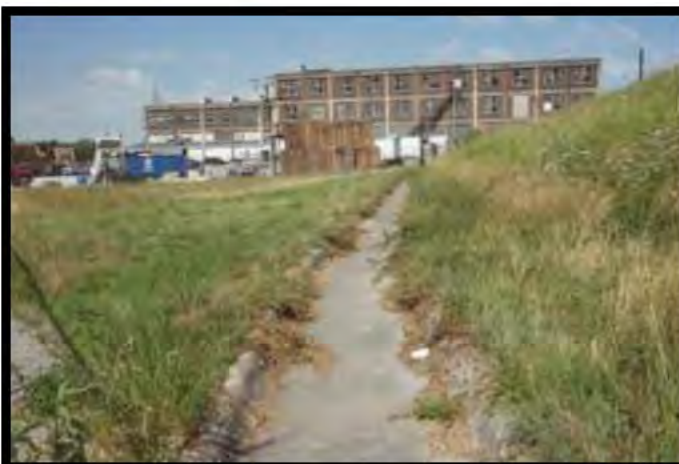
Photograph 47: Vegetation and concrete drainage swale along southern slope of Taracorp pile cap.

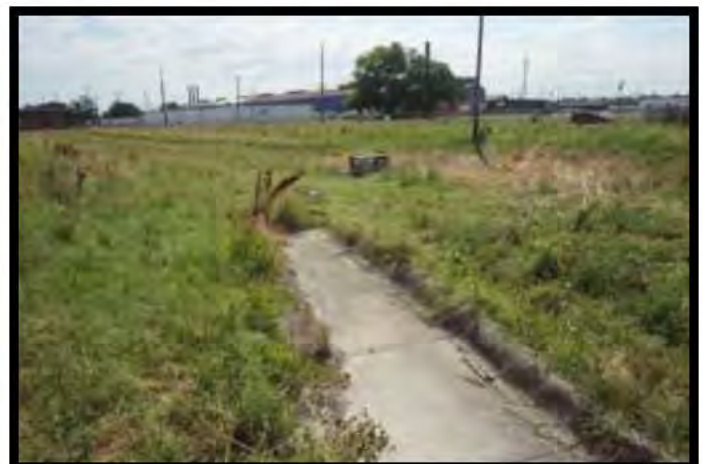
Photograph 48: Concrete drainage swale along southern slope of Taracorp pile.
